# Project Report

## Slope Stabilisation in Miesbach

### Bavaria, Germany

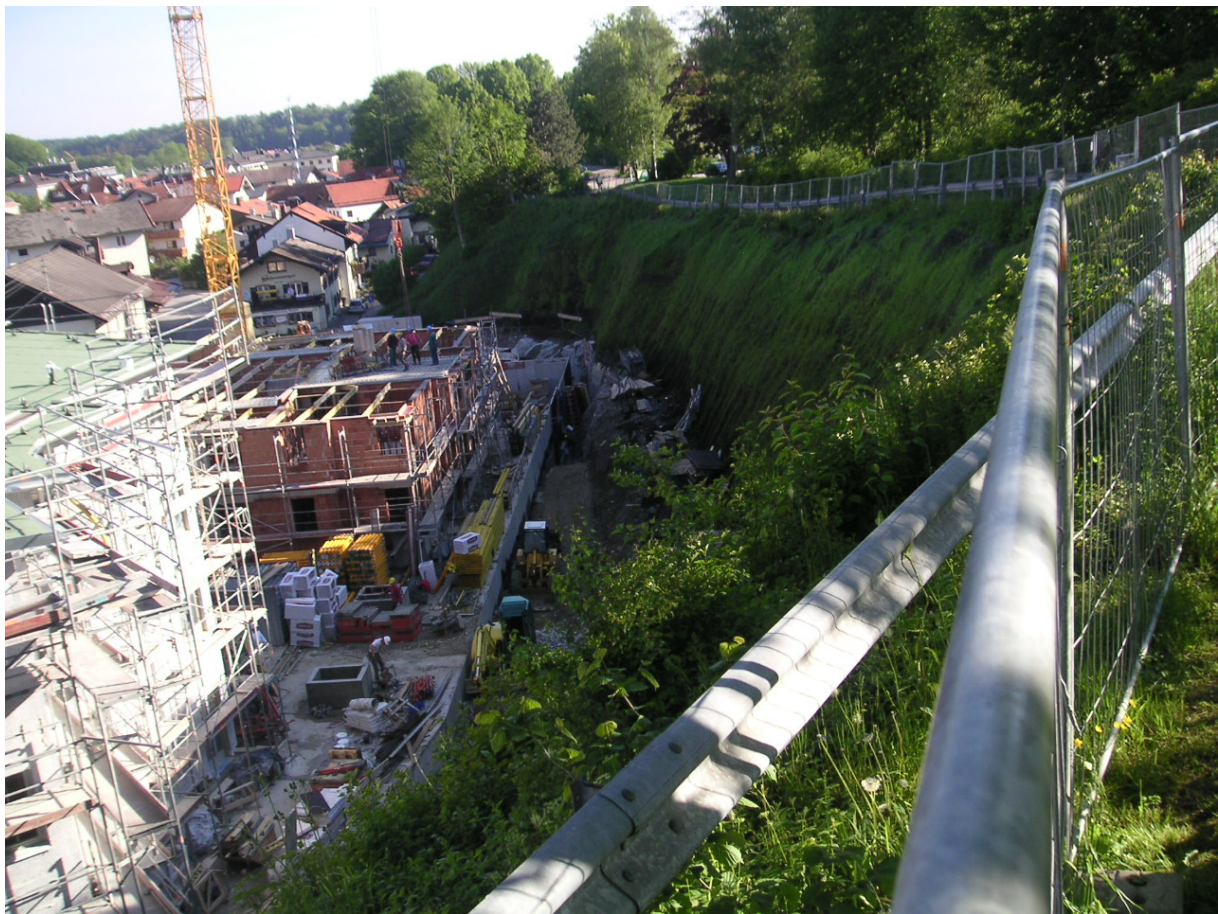
Fig. 1: Finished slope stabilisation

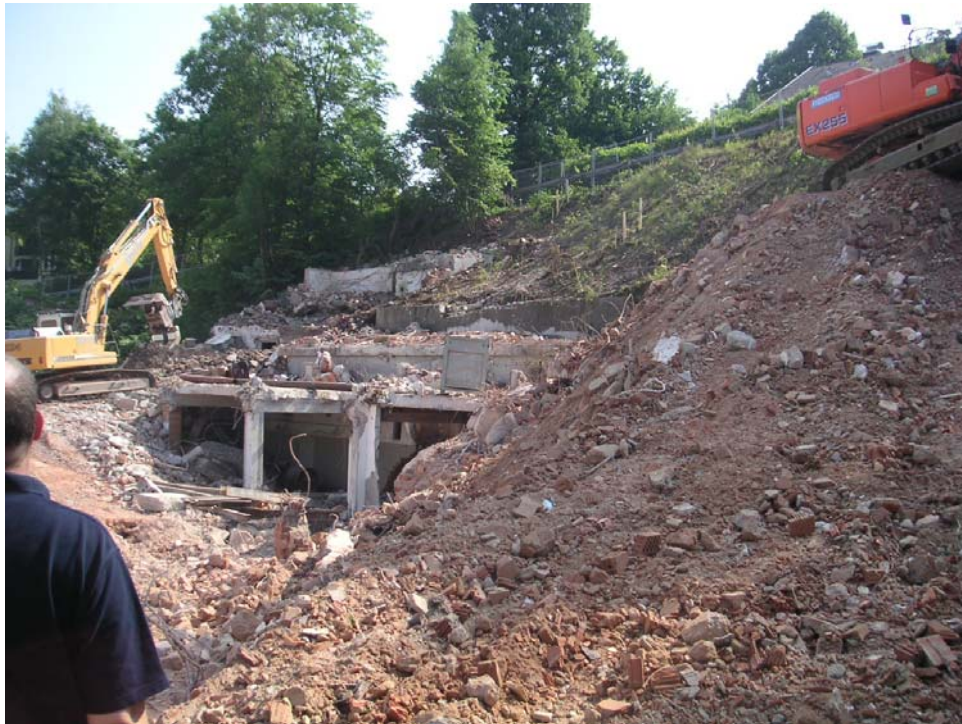
Fig. 2: Initial situation - demolition of the old dairy

During the stepwise excavation of the slope the old buildings of the dairy had to be broken down gradually because they were partially built into the slope.

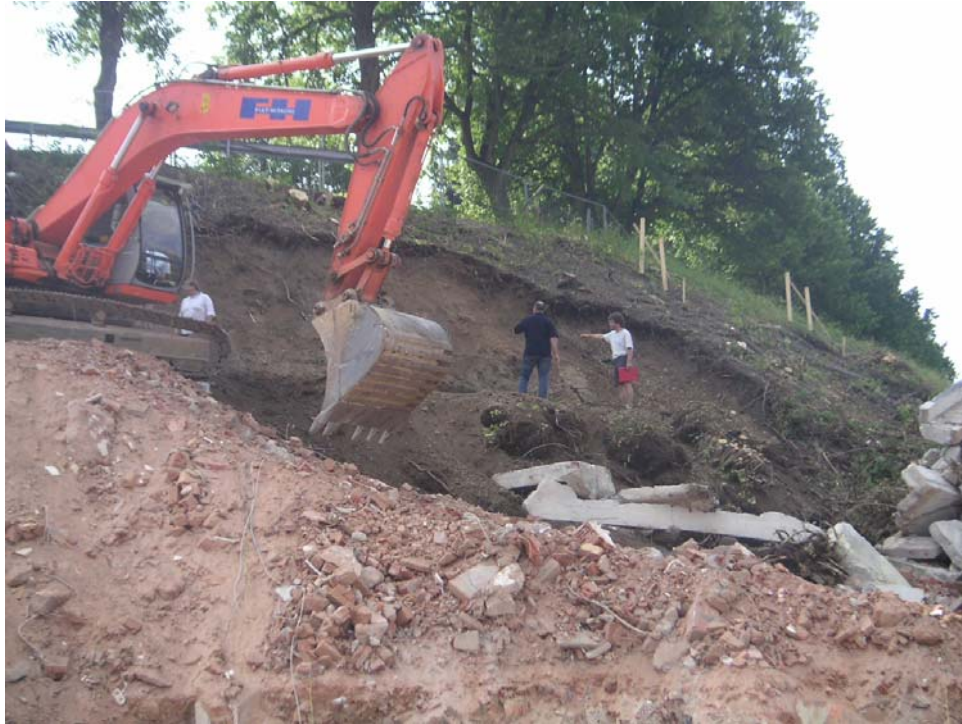
Fig. 3: First excavation step, excavating the new 65° cut slope in stages

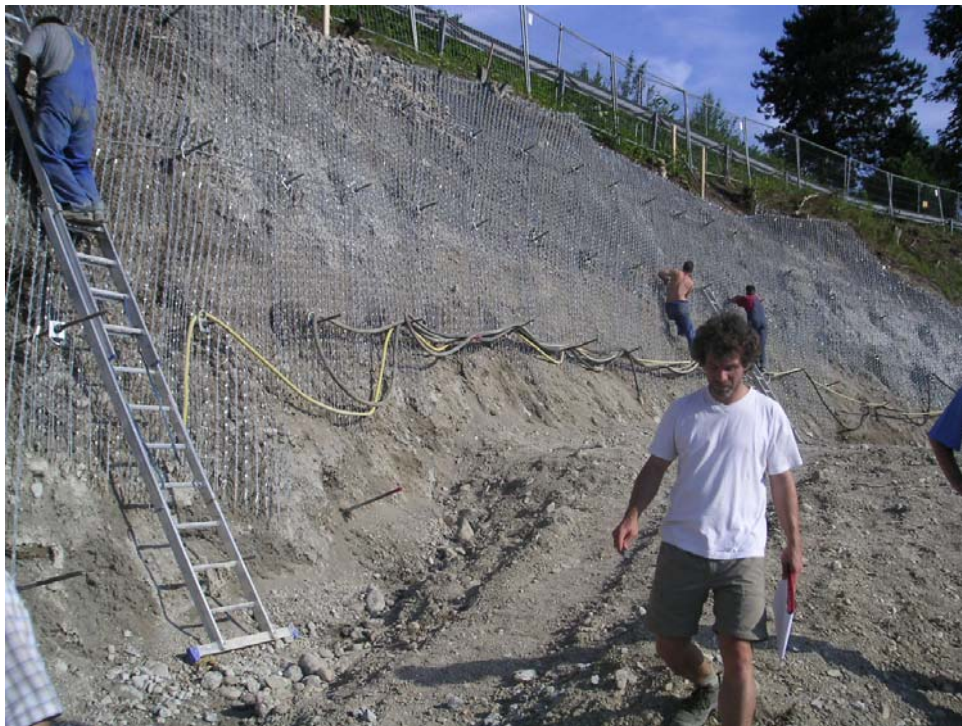
Fig. 4: The excavation work is immediately followed by the stabilisation work for the slope, done from the interim berm

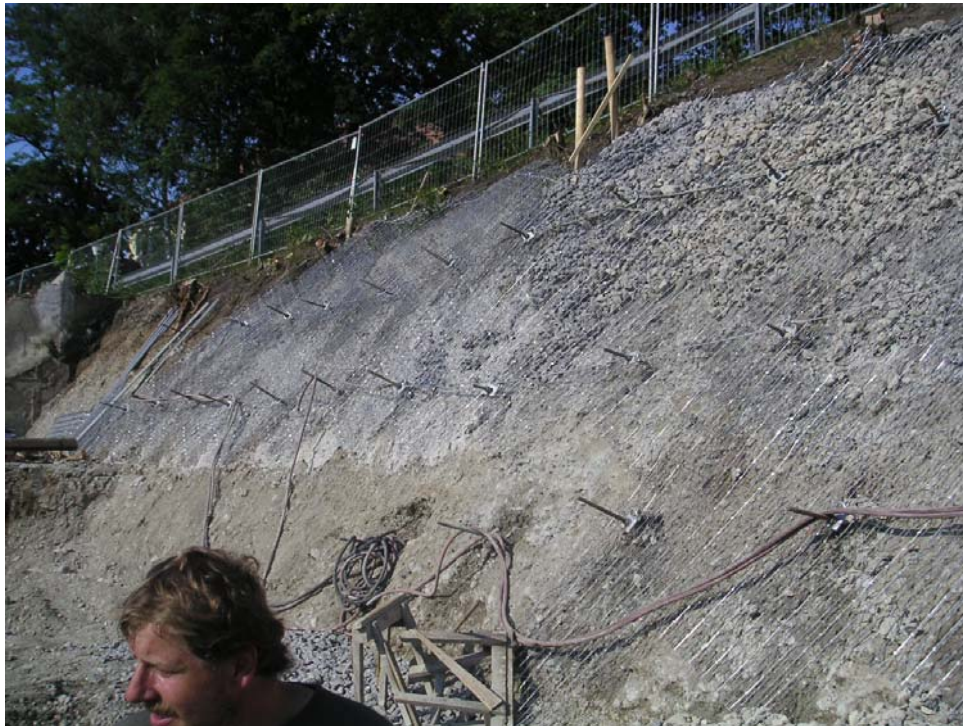
Fig. 5: Second excavation step, immediately followed by stabilisation of the slope

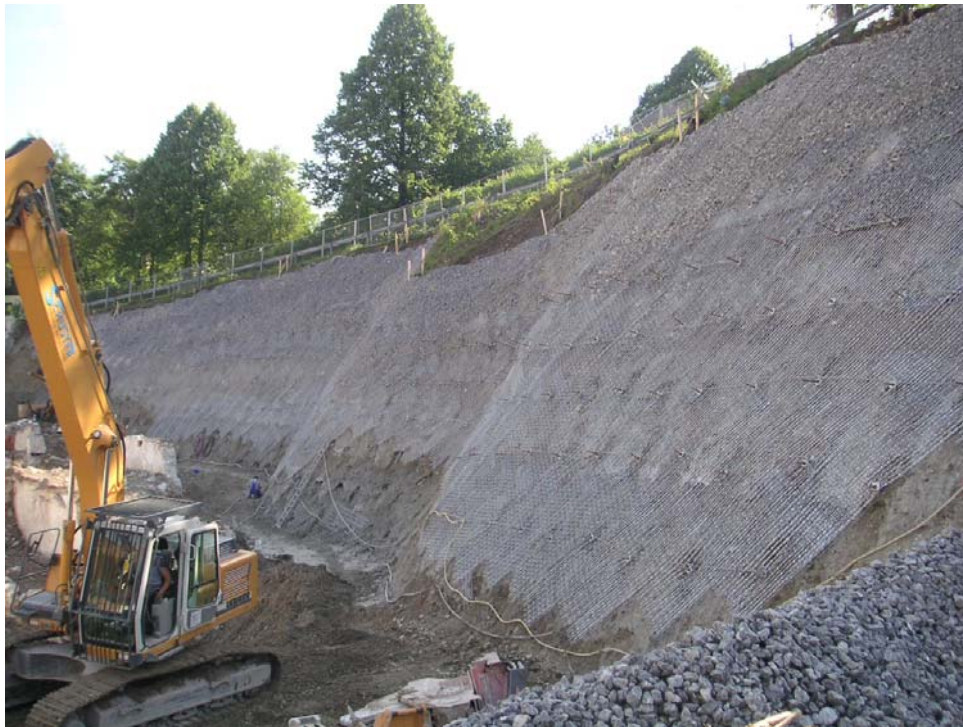
Fig. 6: Finished cut slope, inclination 65°, down to the level of the floor of the excavation pit for the foundation

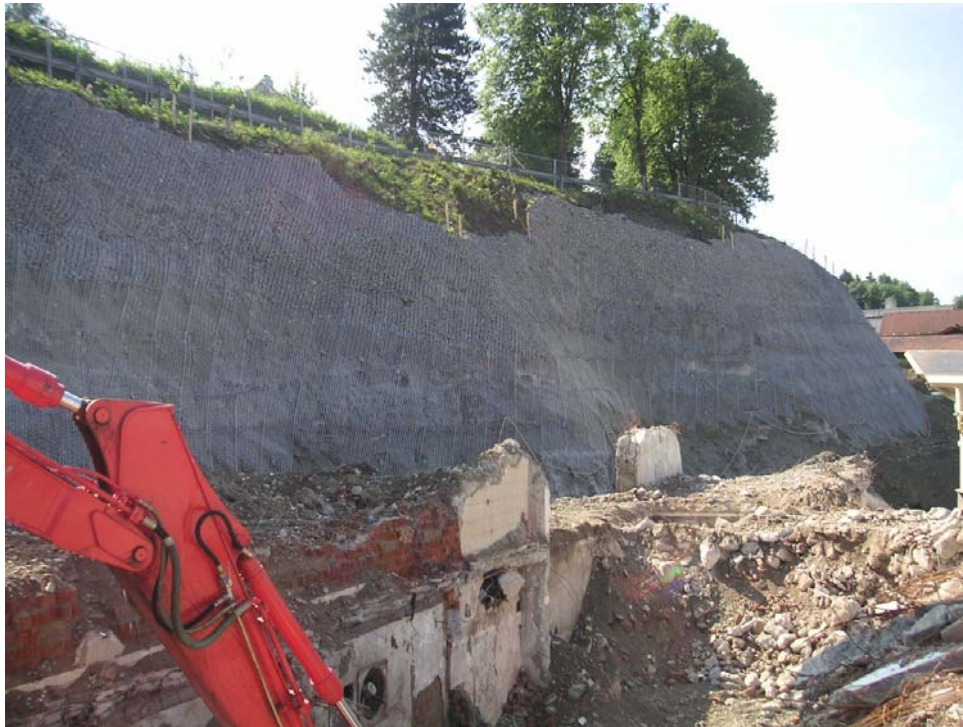
Fig. 7: Beginning the excavation work for the foundation of the apartment houses, with adjoining finished stabilised steep slope

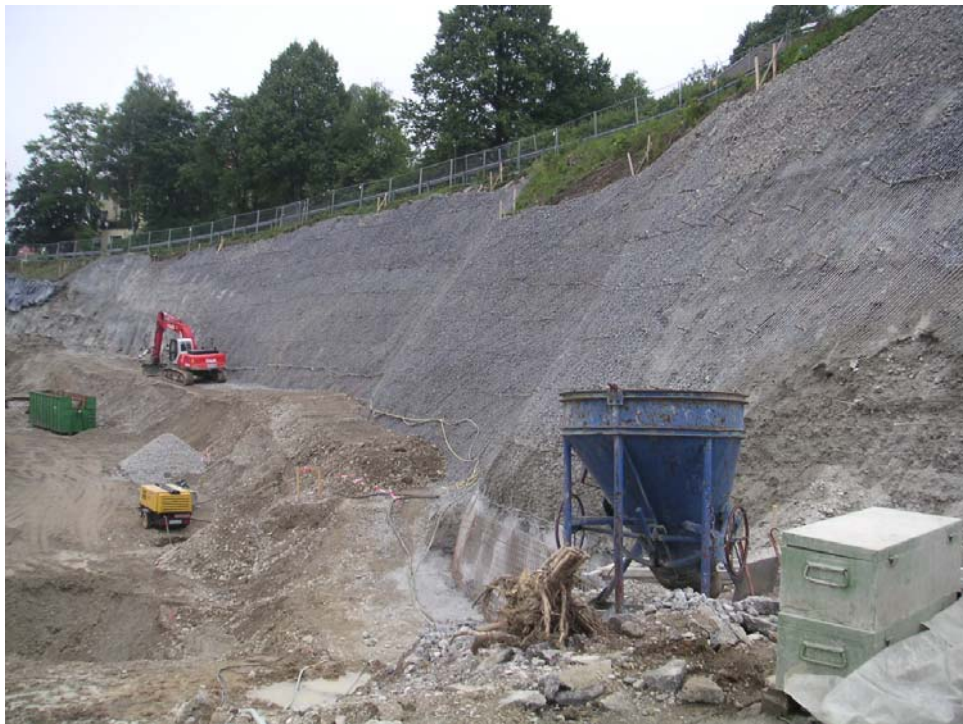
Fig. 8: A crane bucket (in the foreground) with an opening on the side for stone filling

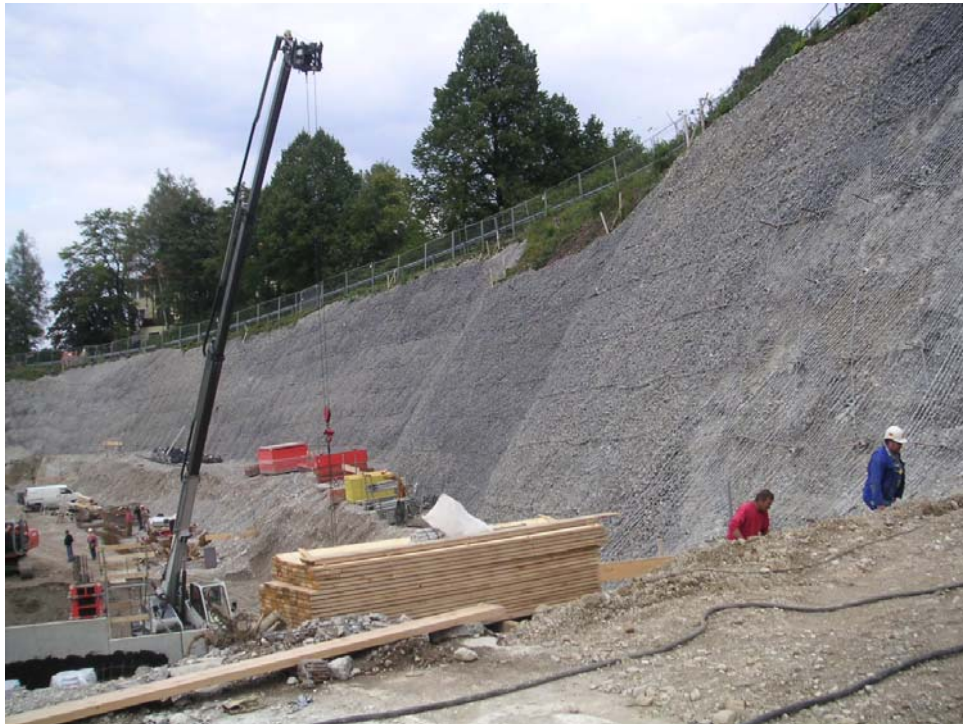
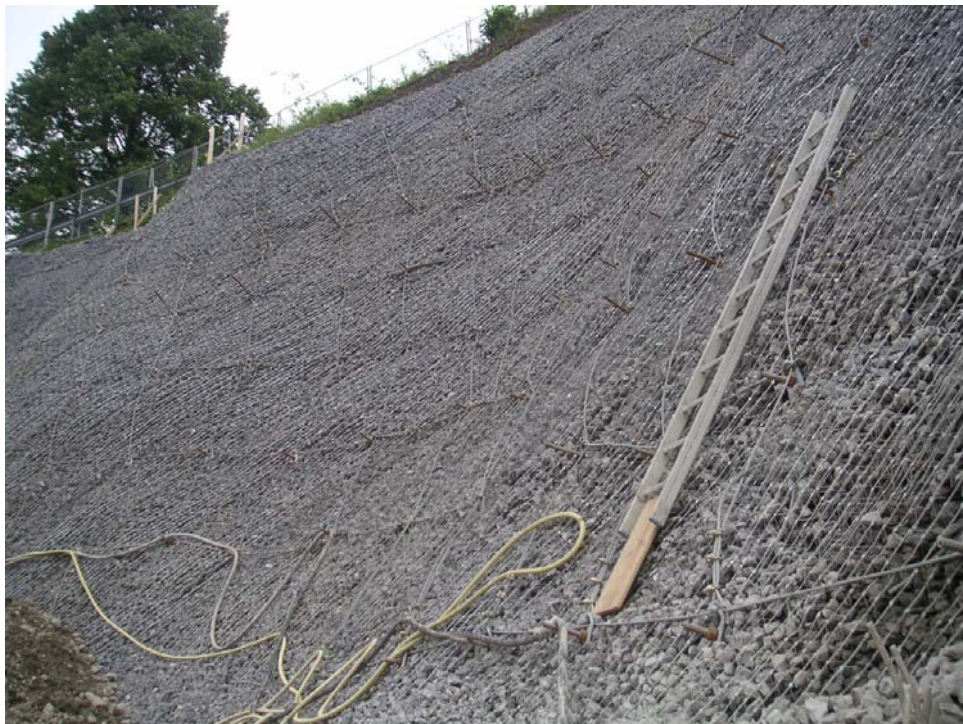
Fig. 9/10: Filling of the anchored lattice mats with gravel, grain size 32/60 mm, Volume approx. 7 - 8 m<sup>3</sup> per 100 m<sup>2</sup>

The three-dimensional J.K.S. steel lattice mats in combination with the stone filling act as a support layer for the humus. In addition, the stone filling makes optimal surface drainage possible. The filling work was done with a crane and bucket from the base of the slope.

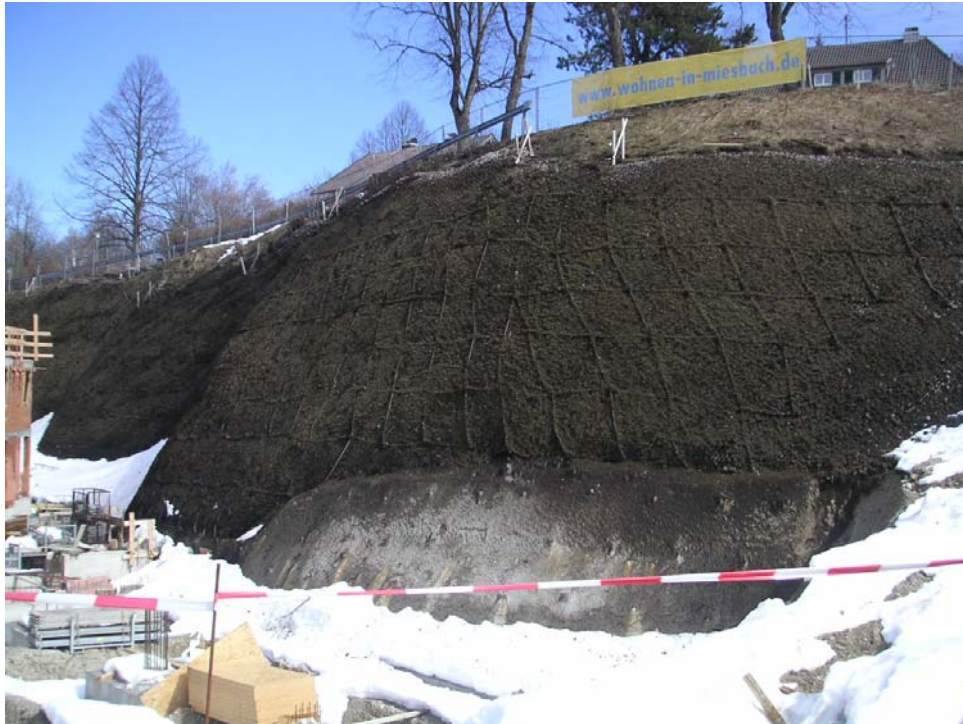
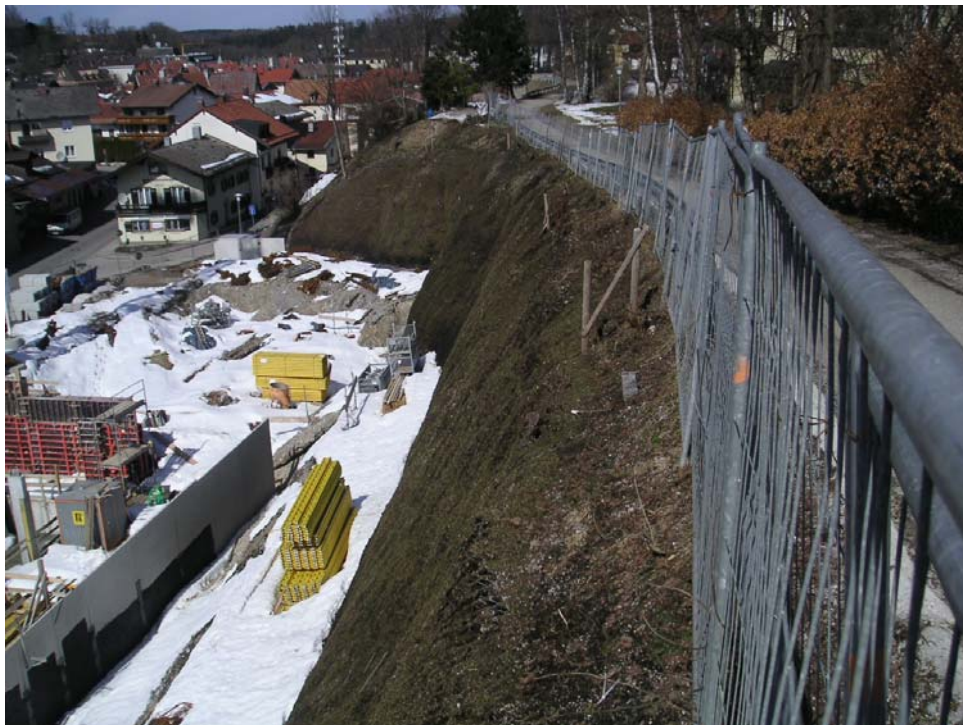
Fig. 11/12: Cut slope, Spring 2006 - The topsoil was applied onto the slope surface using the wet spraying method. Seeds were mixed into the humus during its application.

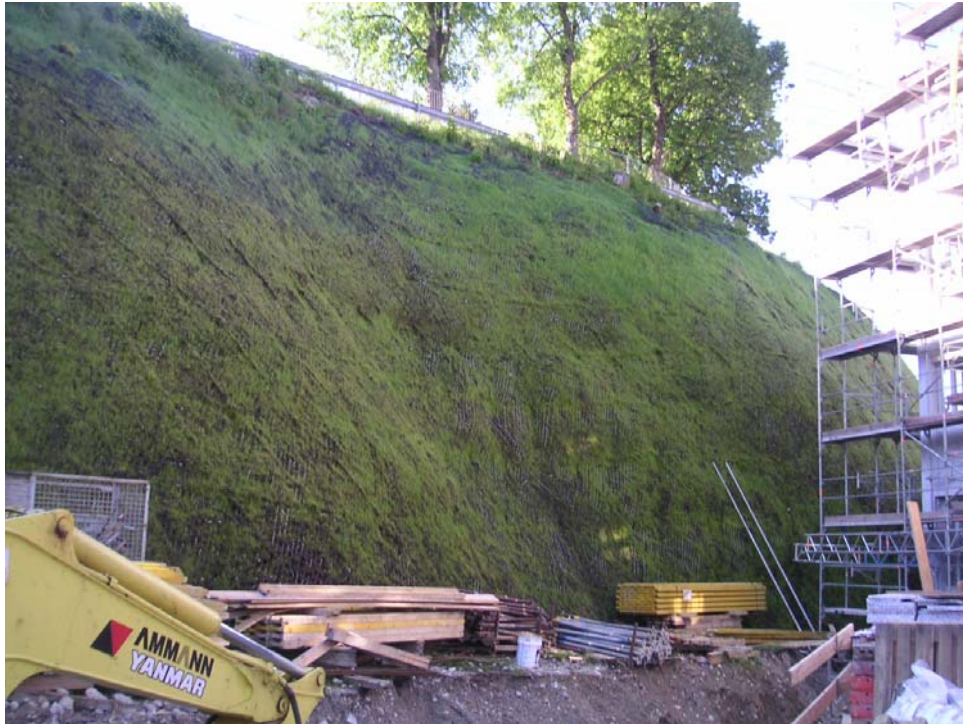
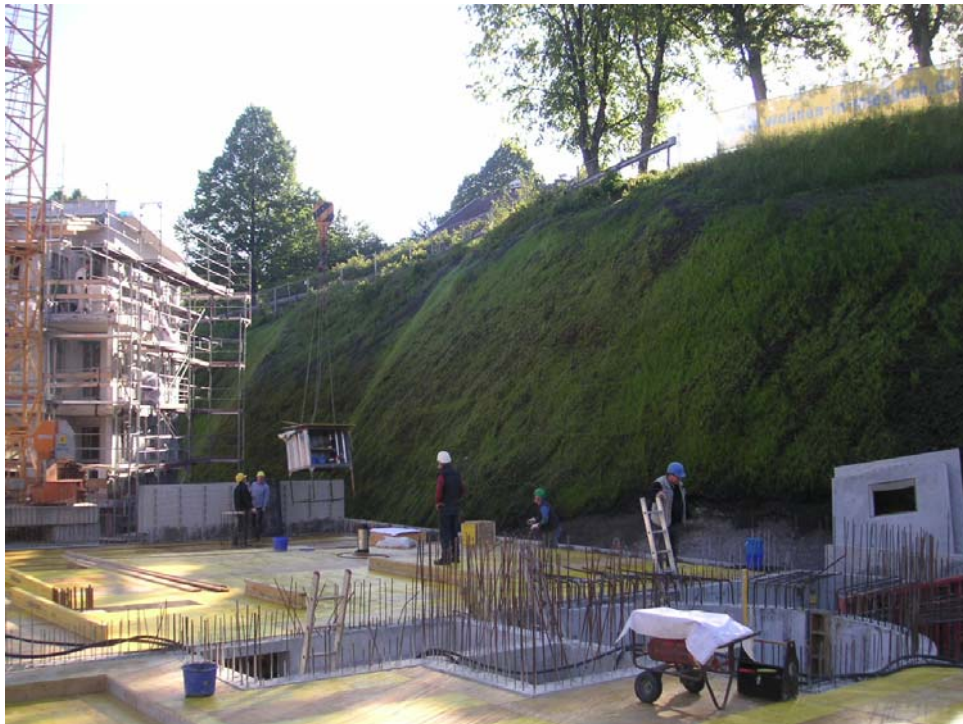
Fig. 13/14: State of the slope in June 2006, surface covered with germinating plants

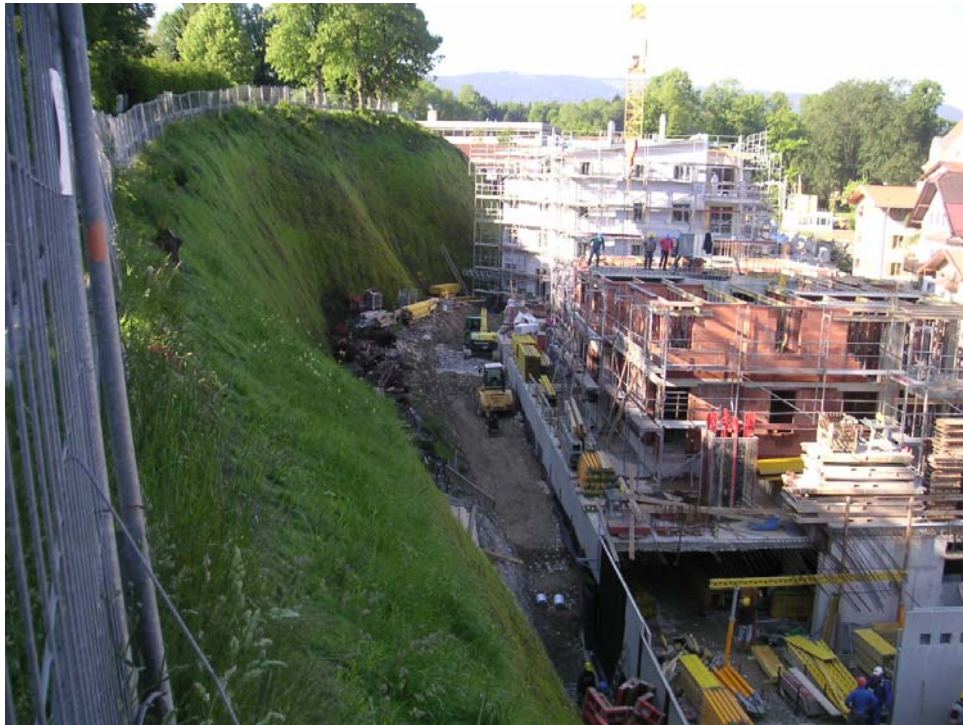
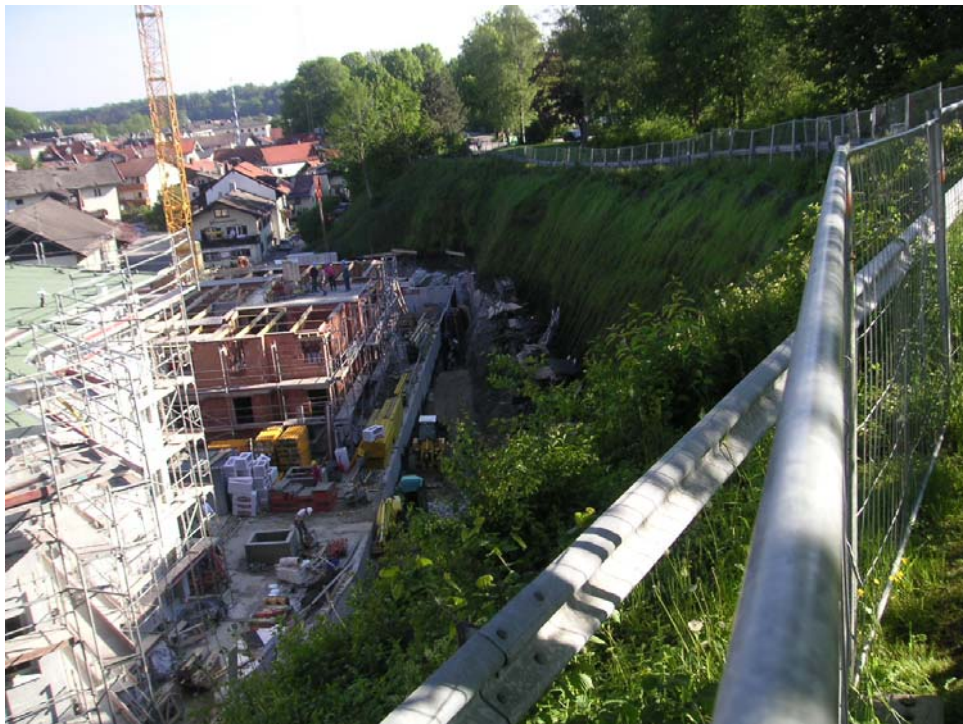
Abb. 15/16: Integration of the Krismer System® approx. 1.50 m over the top of slope into the surrounding terrain

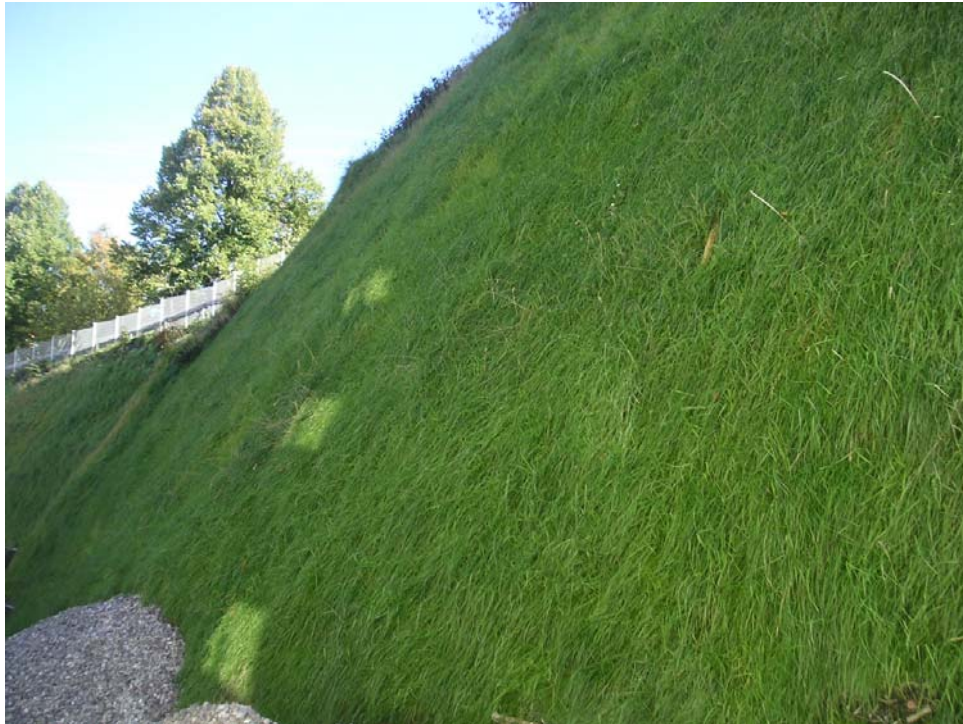
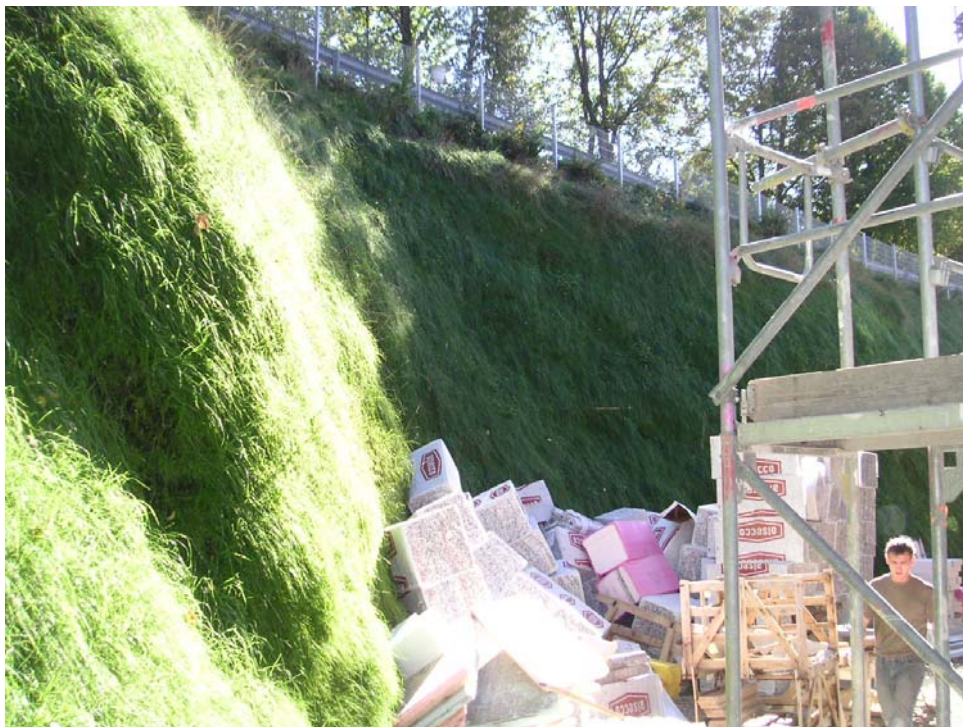
Abb. 17/18: State of the slope in October 2006

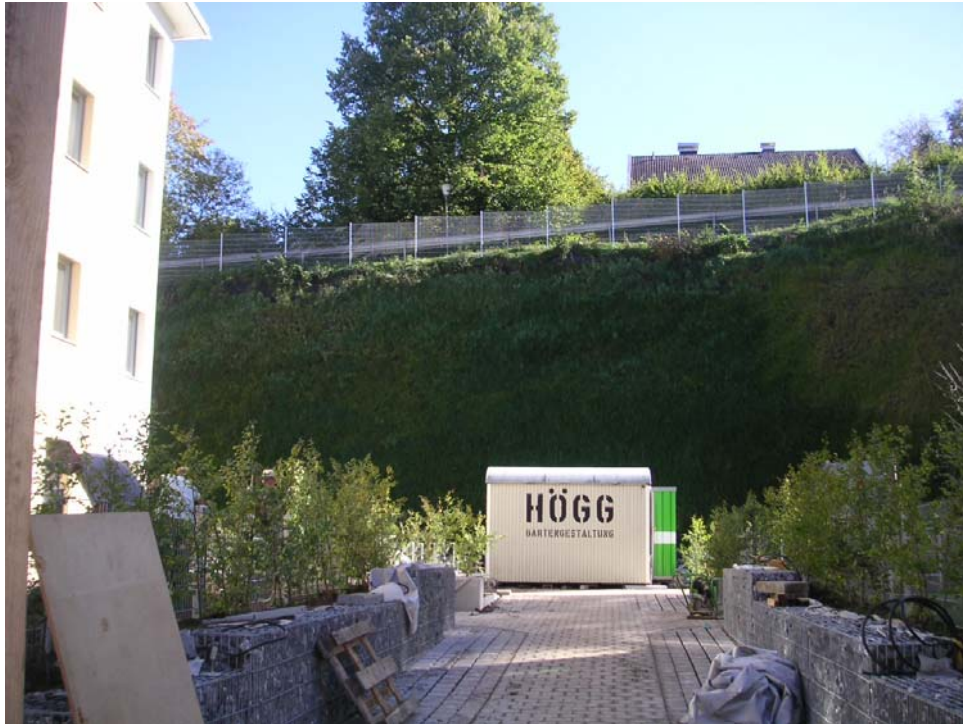
Fig. 19: State of the slope in October 2006

The buildings and gardens are finished. The cut slope with an inclination of 65° and up to 13 m high is permanently stabilised, optimally planted and optimally integrated into the base of the slope and adjacent gardens. The natural character of the surface creates a very pleasant general impression of the housing complex, which is especially important for the well-being of the new owners.

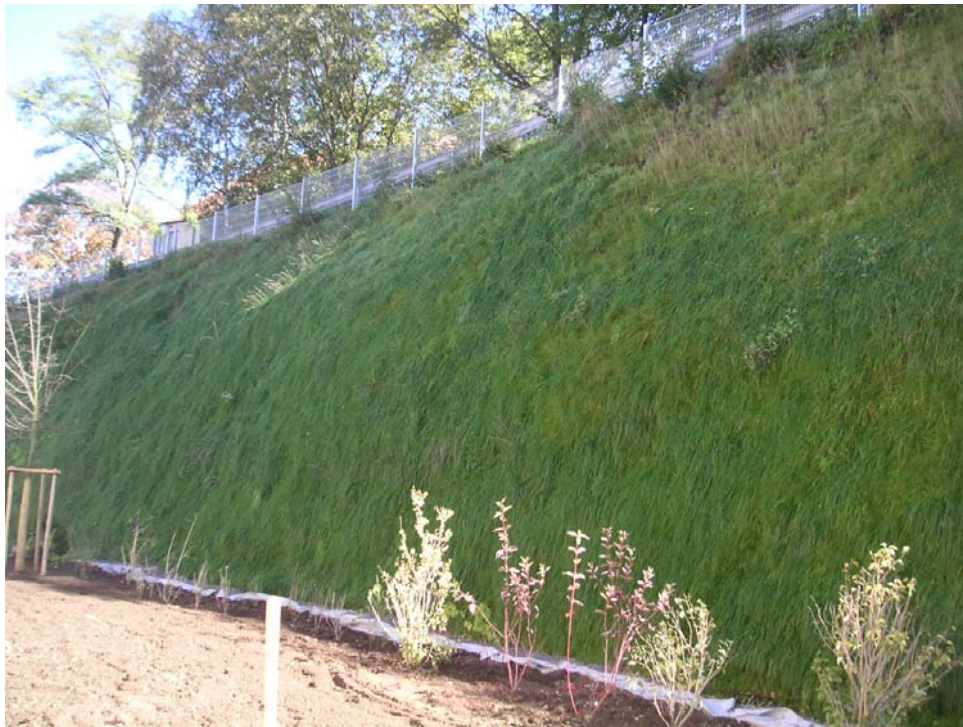
Fig. 20: Finished cut slope combined with to neighbouring gardens
