Project Report Stabilisation of a Steep Slope during construction of the new K 1897 County Road between Backnang and Erbstetten Baden-Württemberg, Germany

SLOPE STABILISATION - K 1897 COUNTY ROAD 8 / 15

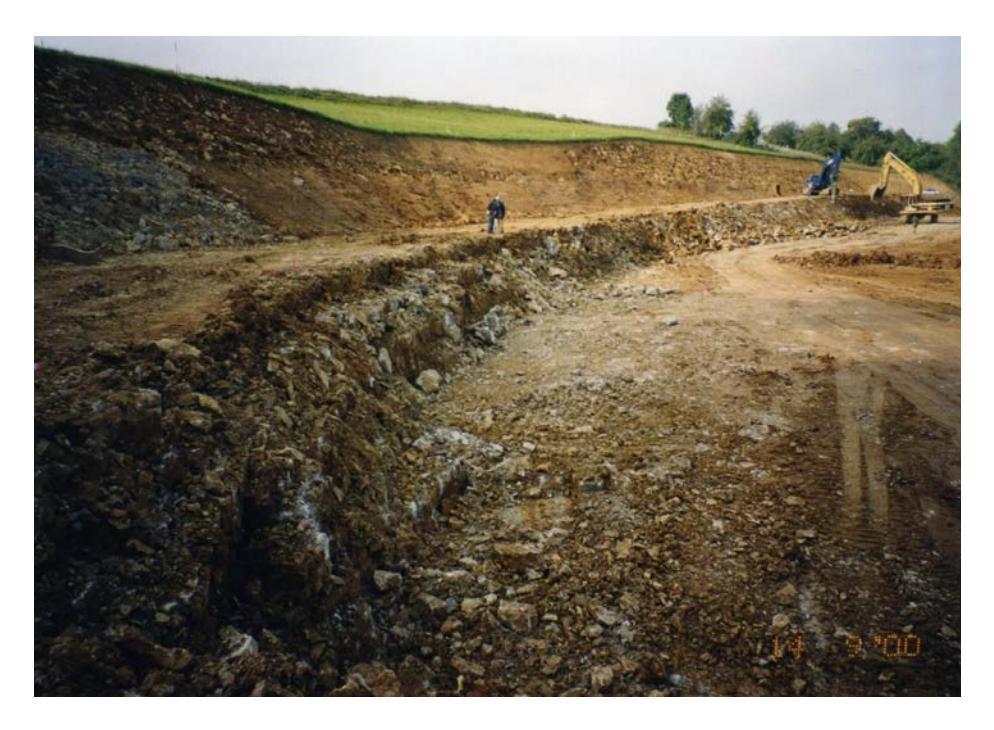
Fig. 1: Earth movement work for the new K 1897 county road

The K 1897 county road had a particularly dangerous blind railway crossing, which induced the authorities responsible for local road safety to build a new section of road that included an underpass beneath the rail line.

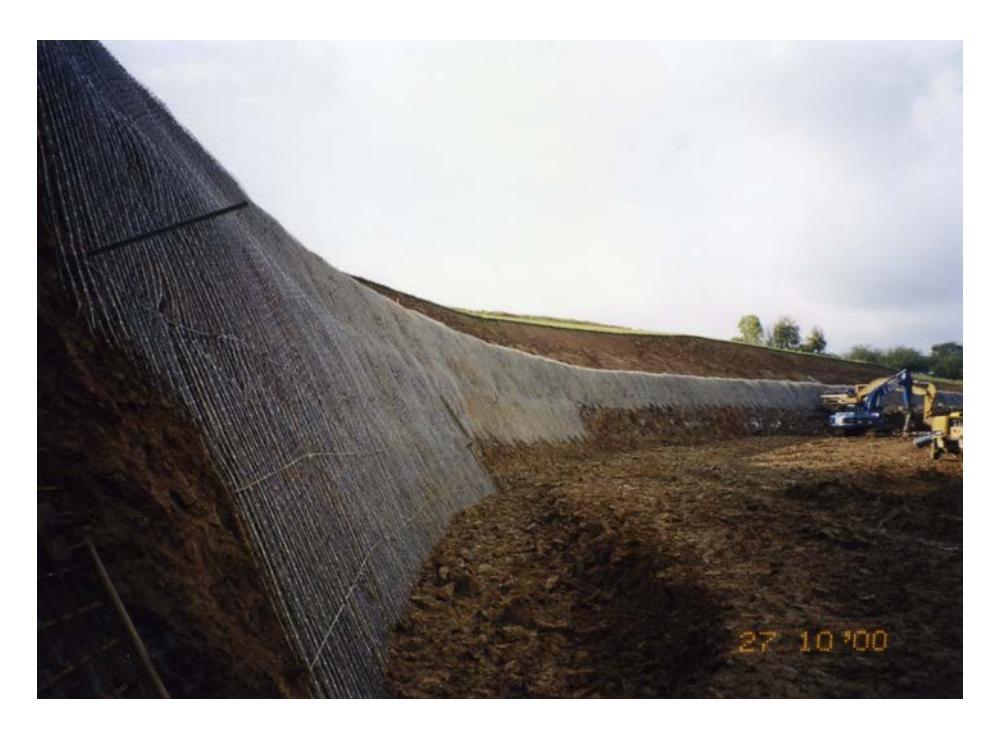
For this the three-dimensional J.K.S. panels were laid on the slope surface at an angle diagonal to the fall line of the slope. The panels were overlapped both longitudinally and laterally and these joints were secured with stainless steel wire binding loops.

The installation was done from top to bottom in three steps, corresponding to the three stages of excavation (vertical height approx. 2-3 m / stage).

Fig. 2: Installation of the Krismer System® in several steps

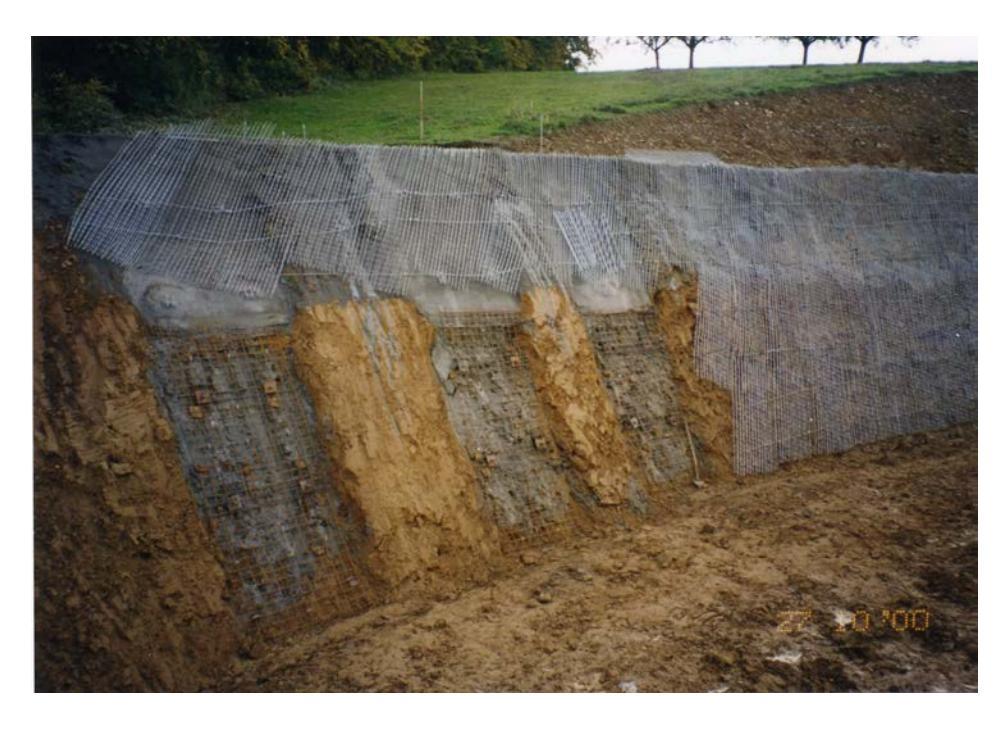
The areas where the slope had high rubble content were stabilised with shotcrete combined with GEWI anchors (fig. 3), the anchor heads were later connected to the J.K.S. panels by means of special connecting-elements.

Fig. 3: Areas which were pre-stabilised with shotcrete and GEWI anchors

First, slope areas with a high rubble content were stabilised with shotcrete and GEWI rock bolts (length = 3 - 5 m). Afterward, the whole slope surface was cleaned and uneven terrain was back-filled.

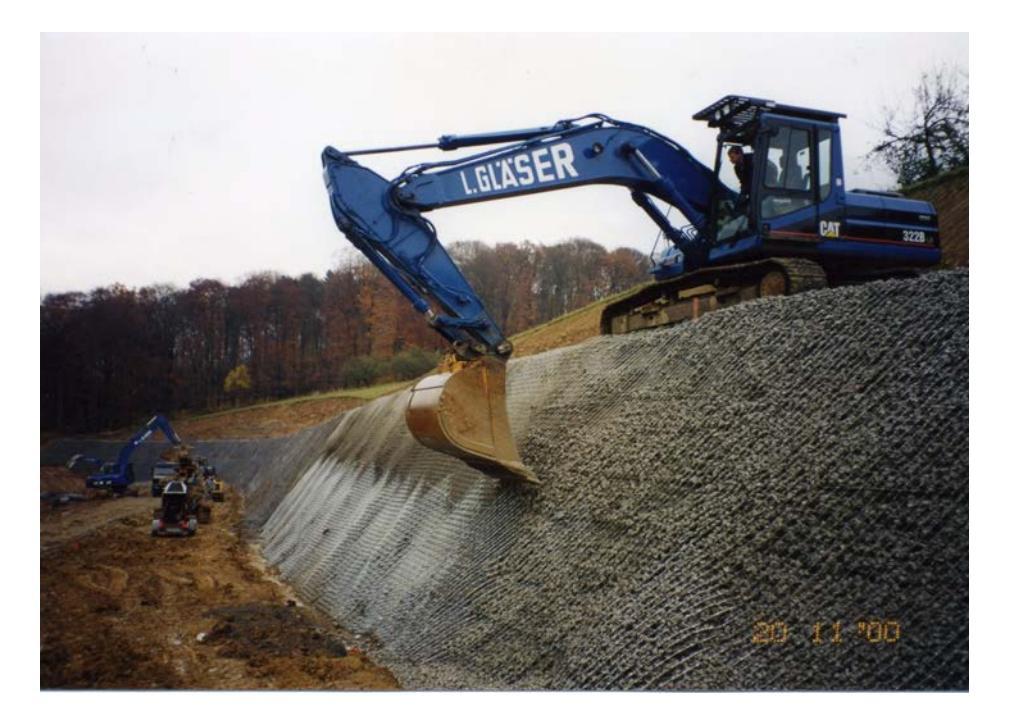
After the J.K.S. panels were anchored they were filled with gravel (grain size 32/60 mm). This work was carried out with a bank-hoe from the top of slope (fig. 4).

Fig. 4: Gravel filling (grain size: 32/60 mm)

The gravel filling provides surface drainage which enables both surface and ground water to be led away.

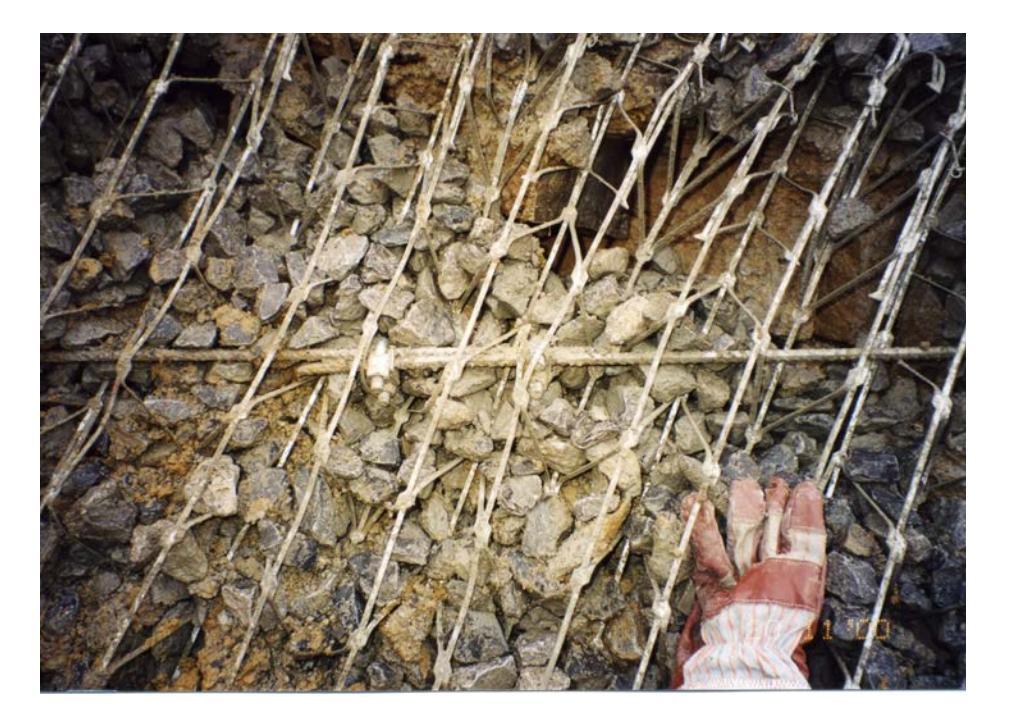
The gravel filling (up to about half the height of the three dimensional J.K.S. panels) combined with the 3D steel structure, provide extra grip to hold the top soil fill layer that is later added.

Fig. 5: J.K.S. panel with gravel fill

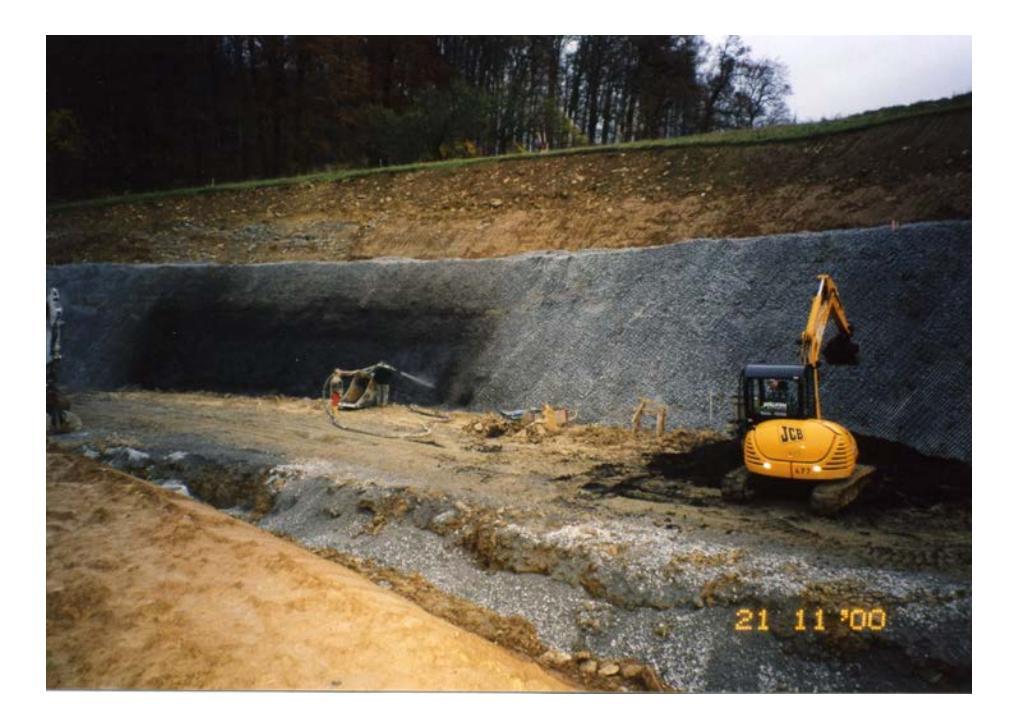
Fig. 6: Filling the top soil by means of a spraying machine

The spraying machine was filled with prepared, dry top soil which was blown by compressed air through conveyor tubes and later mixed at the exit nozzle with the amount of water necessary to make the soil adhere to the gravel filled J.K.S. panels. Soil/water dosage is calibrated by the nozzle operator.

The resulting soil/water mixture that is blown into the J.K.S. panels is compressed and adheres to the slope permanently.

Afterwards top soil was filled into the J.K.S. panels using the dry spraying method.

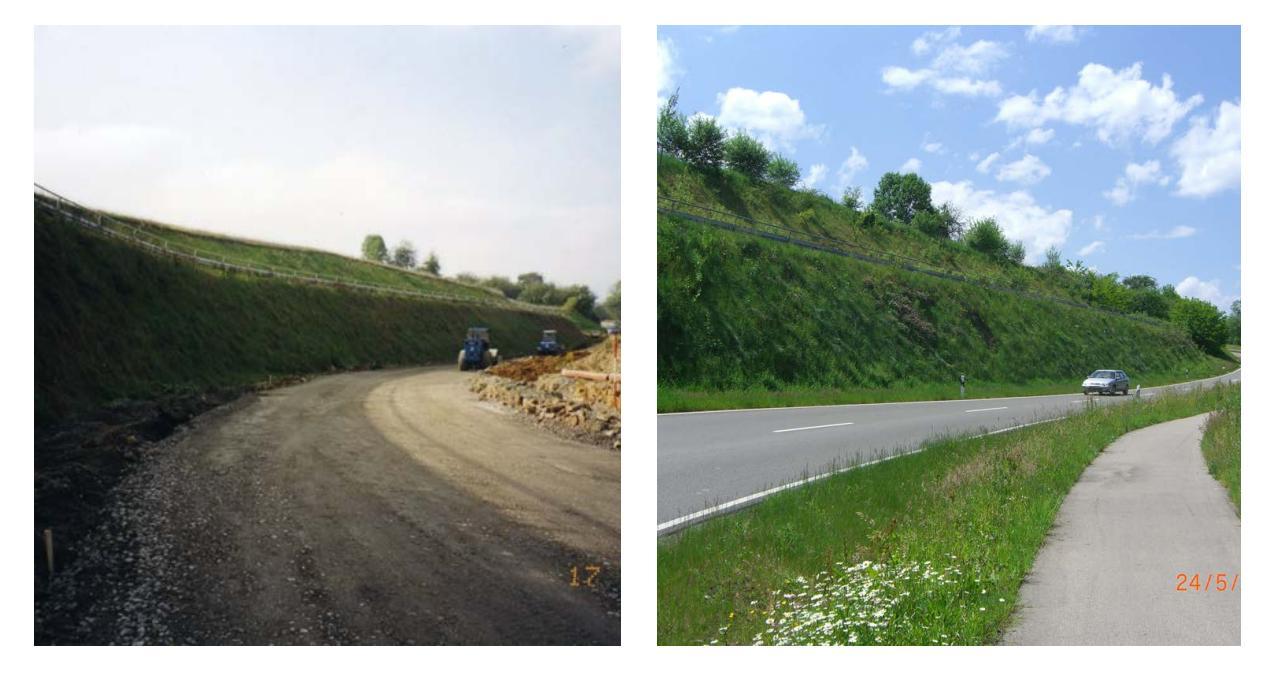
Fig. 7-8: Slope stabilised with the Krismer System®: 1 year (Fig. 7 - left) as well as 6 years (Fig. 8 - right) after the installation was completed

- the slope was thoroughly stabilised
- fragmented rock was permanently protected from damage caused by varying weather conditions (e.g. frost)
- the gravel filling forms a suitable surface drainage to lead away water emanating from rock fractures
- the stabilised layer of top soil forms a base for long lasting plant growth
- a slope was constructed with an inclination that complied with road design requirements, while offering optically perfect landscape integration.
- \bullet compared to retaining structures, huge cost savings could be attained with the application of the Krismer System®
